Section 5.0

Visual Themes and Zones

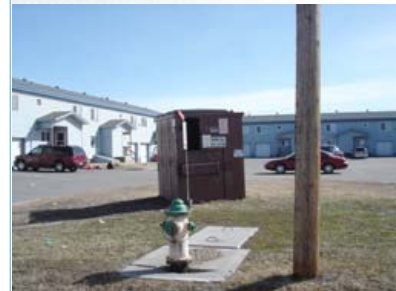
The visual character within family housing presents a feeling of disorganization due to the lack of landscape elements or architectural features to provide a sense of place within a neighborhood unit. The architectural style of the housing units varies from one side of the street to another due to the timing of the construction of the particular units. The density of the units is high due to the lack of suitable land for construction. The undefined open space between the housing structures is accentuated due to the lack of trees or landscape elements to soften, frame or screen views. Placement of dumpsters within a housing area is random and uncontrolled as shown in Figure 5.4f. Playground equipment has been placed within housing areas at locations isolated from most housing units and paved access routes have not been provided, see Figure 5.4g. Landscape treatment within the housing area is random and minimal. The flat open terrain and overhead utility lines adds to the spatial disorganization within the housing units and a lack of definition between neighborhoods, see Figure 5.4h.

▲ **Figure 5.4f**
Placement of Dumpsters Lacks Organization

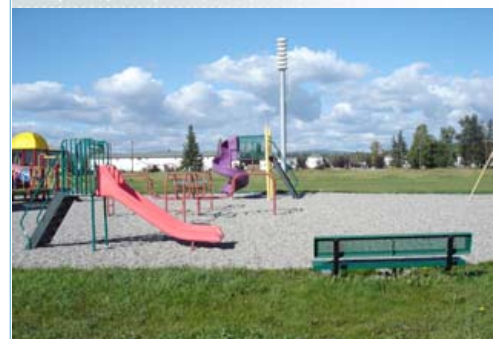
▲ **Figure 5.4g**
New Playground Lacks Paved Access Routes

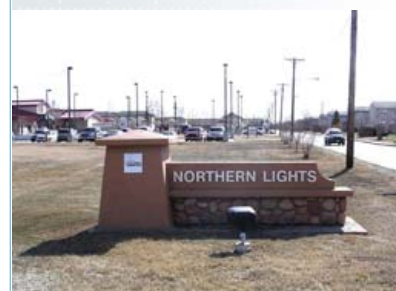
▲ **Figure 5.4h**
Existing Open Space at Neighborhood Entrance

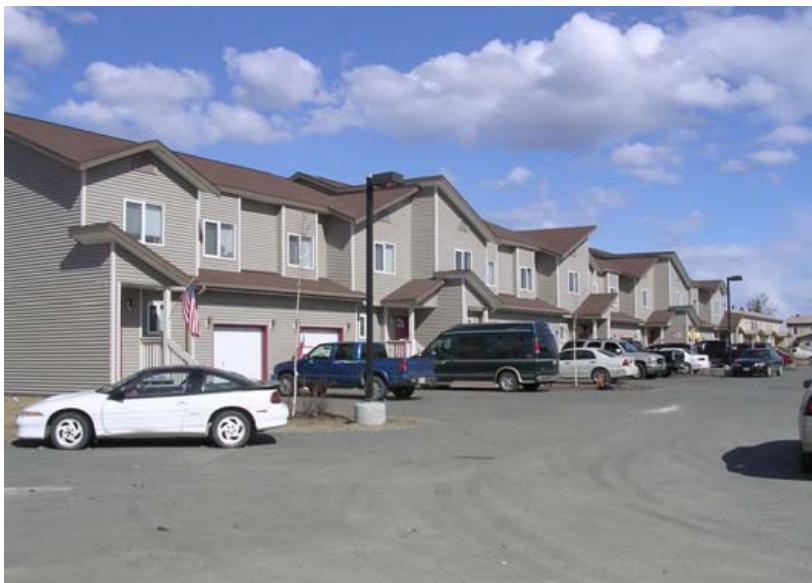
The family housing area is an open flat plain which has been created by the removal of native tree cover. The development of the housing units has taken place over a period of time where architectural style and construction methods and standards have changed with each development cycle. This has led to a disorganized appearance within the housing community. The lack of site amenities, landscape treatment or architectural features within the various housing groups has led to a lack of spatial organization and neighborhood identity. See Figure 5.4i.

▲ **Figure 5.4i**
Housing Units Lack Space Organization

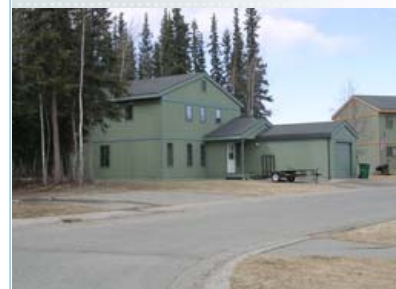
A bike path begins on the south end of the housing area and continues along Alder Avenue, ending at the intersection of Meridian Road. Walkways are installed in the newer housing areas, but a complete pedestrian walkway system is lacking in the older areas. Pedestrians within these areas must walk in the roadway or on unpaved paths. Figure 5.4j.

▲ **Figure 5.4j**
*Pedestrian Walkways
are Required*

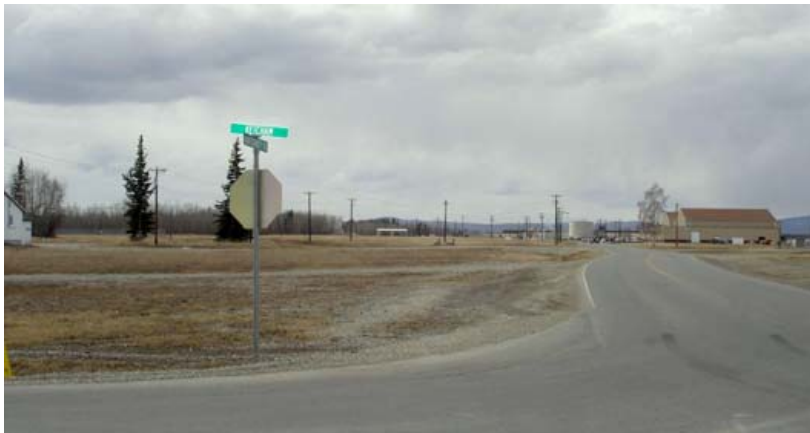
▲ Figure 5.5g

The Historic Landmark Visual Zone consists of all facilities located within the boundaries of the landmark district including view sheds from the field. The vistas from both ends of the runway are attractive and add context to the overall site. The alluvial plain on which the airfield was constructed has little to no topographic relief. The architecture of the facilities within the landmark district is utilitarian, consisting of large hangars and smaller support facilities for airfield operation. Hangars 2 and 3 are Birchwood Hangars and are two of the three remaining in the world; the third is located at Fort Greely, Alaska. Gaffney Road and Ketchum Road both cross the end of the runway within the glide path of aircraft using the field. Little security protection is present in this area with Ketchum Road in close proximity to the aircraft fueling point. Overhead utilities distract from the open space, however they do provide a definition of the perimeter of the area. See Figures 5.5g and 5.5h.

Overhead Utility Lines Define Area

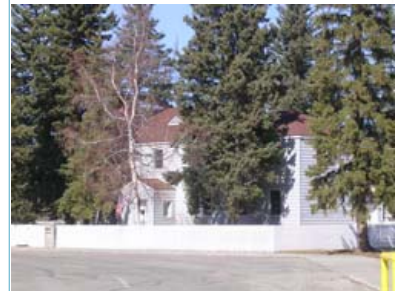
The existing plant material in this area is mature spruce trees and some birch at various locations adjacent to some of the structures. There is a lack of uniformity to the plantings; some buildings have no plantings, trees have overtaken the Commanding General's home site and limit the view of the home to a small portion of the house. See Figure 5.6e.

▲ **Figure 5.6e**
Overgrown Trees

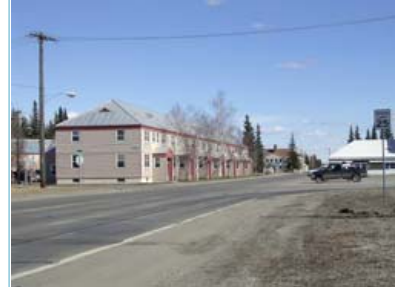
Landscape planting along Gaffney is mature but limited to a few small areas. Where there are street trees the size and placement can restrict views of nearby intersections due to their size or location as depicted in Figures 5.6i and 5.6j. Drive entries are poorly accented by landscape plant material to denote a point where cars would enter the roadway. The large rock boulders placed along Gaffney adjacent to the administration building are not in keeping with the historical architectural theme of the area and should be replaced with a more appropriate security barrier in keeping with the historical context of the area.

▲ **Figure 5.6i**
Existing Landscape Along Gaffney Road

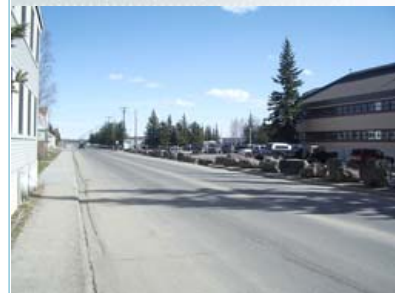
▲ **Figure 5.6j**
Existing Streetscape

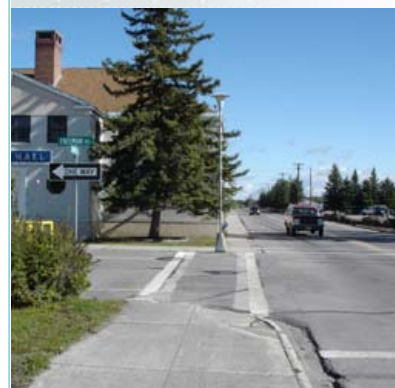
The site of the historical information signs is not accessible by a walkway and does not present the importance of the events it depicts. Roadway signage along this section of Gaffney is cluttered, poorly maintained, and lacks order. See Figure 5.6k. The most mature and appropriate street tree planting exists in front of the Bureau of Land Management offices.

▲ **Figure 5.6k**
Existing Roadway Signage

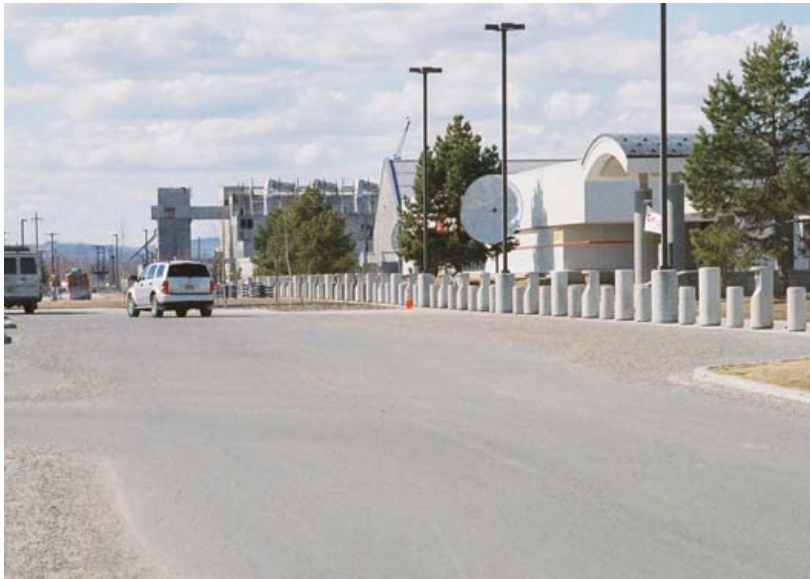
▲ **Figure 5.8c**
Exchange/Commissary Facility Entrance

The exchange and commissary facility is situated between two major north-south roadways in the center of the installation. It is a fairly new facility with a large paved parking lot immediately in front of the facility. There are no parking lot islands due to snow removal operations, and no separation between the parking lot and the roadway serving the parking lot to the south. There is not a primary roadway serving the site which creates traffic congestion during peak periods of the day. Pedestrian access to the site is restricted to walking in the roadway with passing vehicles, or on worn pathways across open ground. It is a heavily used area which lacks the infrastructure to support the traffic generated by the facility. Figure 5.8c shows the present site conditions leading into the area.

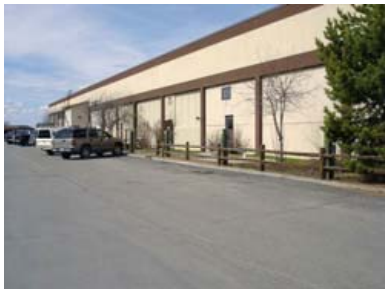
The DPW shops building is both an administrative office building and a maintenance and construction equipment shop with a large fenced storage area behind the building. The front of the building has three entrances leading from the gravel parking lot which is adjacent to Montgomery Road. The visual impact of the facility is typical of most buildings in the industrial area. The landscape plant material adjacent to the front of the building is minimally maintained and the building entrances are not well defined. See Figures 5.11c, 5.11d, and 5.11e.

▲ **Figure 5.11c**
Existing Building Landscape Treatment

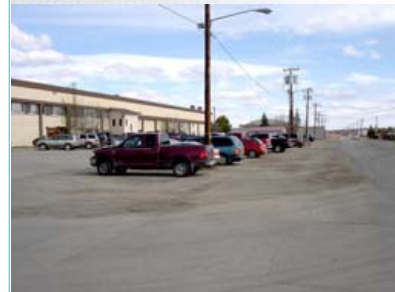
▲ **Figure 5.11b**
Parking is Not Well Defined at DPW Shops
